Byron G. Rogers U.S. Courthouse, Denver, CO

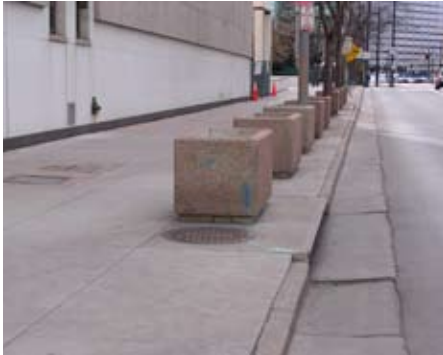
19th Street before renovation

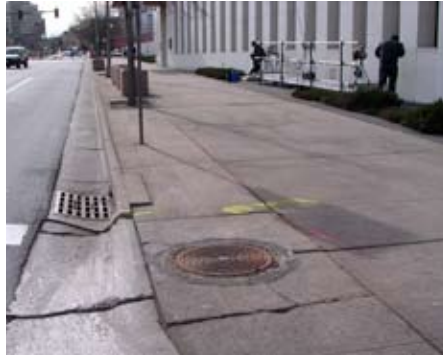
20th Street before renovation

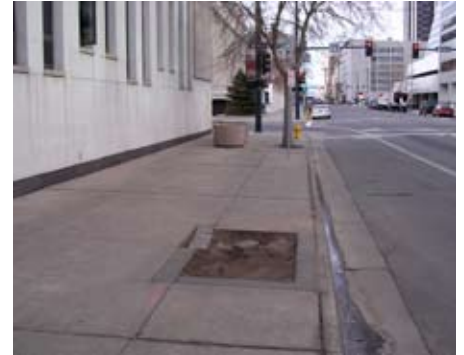
Champa Street before renovation

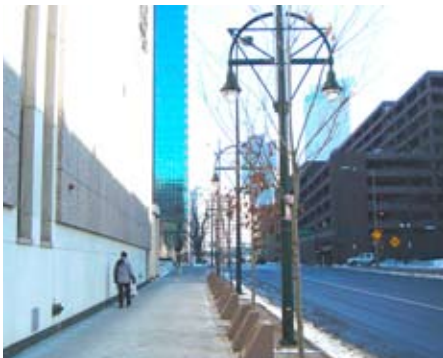
19th Street after renovation

The final design meets all three changes. Plants used are below 18" in height so as not to conceal any small packages. Xeric plants were selected to reduce the water use. The new irrigation system is designed to minimize water loss and meet the specific needs of the xeric plantings. New trees were planted in the right of way on three sides of block. These trees complement the existing streetscape design and work in concert with other site elements which include new security bollards.

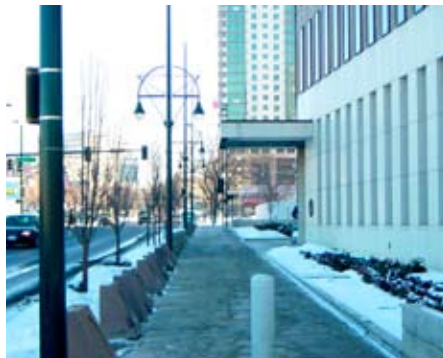
20th Street after renovation

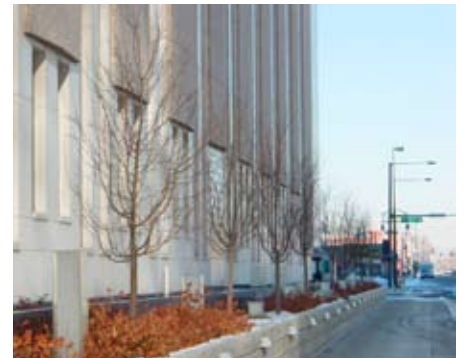
Champa Street after renovation

The Champa Street side of the project was designated as a 1% for art installation. Lime Green Design worked with an artist to select plant material for the raised planters that enhanced his glass cube sculptures.
